Re: **Southwest New Mexico Regional Landfill; MSGP; SIC 4953; NPDES Compliance Evaluation Inspection; NPDES #NMU001958; January 17, 2018**

**Southwest New Mexico Regional Landfill
Compliance Evaluation Inspection
NPDES Permit No. NMU001958
January 17, 2018
Further Explanations**

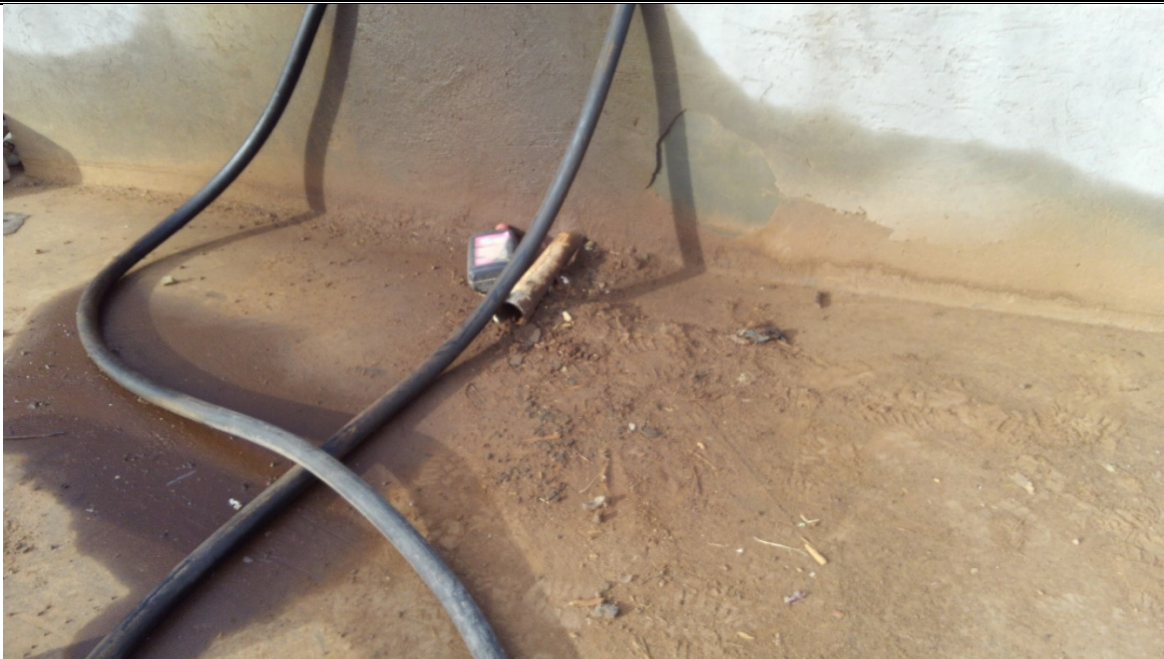
NMED/SWQB Official Photograph Log Photo # 2		
Photographer: Jennifer Foote	Date: 1/17/18	Time: 3:36 pm
City/County: Silver City/Grant Co.	State: New Mexico	
Location: Southwest Regional Landfill		
Subject: open drain pipe from diesel secondary containment

The current SWPPP states that the facility has been designed not to discharge and therefore there are no procedures for sampling or monitoring of discharges included in the SWPPP and no records of any visual or analytical monitoring if a discharge did occur. The plan alluded to at least one area where the berm had broken down and required repairs and monitoring for the no discharge statement to be fulfilled. During the January 17, 2018 inspection, several areas were noted where stormwater could enter the arroyo or otherwise leave the property. The plastic drainpipe on the diesel secondary containment was open and there were signs of staining on the ground.

SWSWA has received and reviewed the inspection report that was completed on January 17, 2018. Attached you will find photos that show proof of remedy of the issues addressed in the report. In regards to the SWPPA update, SWSWA is currently contracted with Gordon-PCS to update and renew the current SWPPA and become compliant with USEPA and NMED requirements.
